RMB ENVIRONMENTAL LABORATORIES

2021

Clearwater Lake Plant Survey

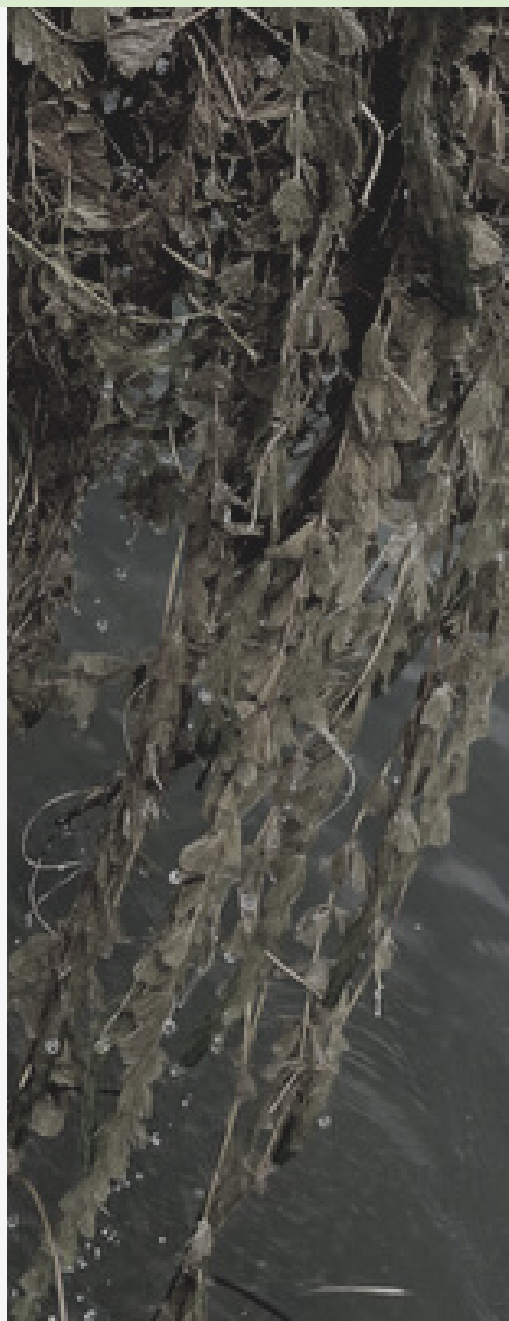
Plant abundance was greatest between five to eight feet of water. As depths increased beyond that range, the presence of vegetation decreased and became less dense (Figure 4).

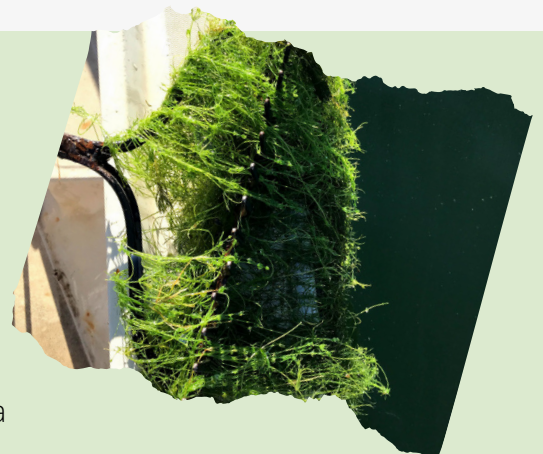
Chara is a native macro algae that typically grows in shallower areas of the lake. It has a strong musty odor.

Chara is a macro algae that feels crunchy and has a distinct musty odor. Sometimes chara is referred to as a muskgrass and it is often found in shallower areas of the lake. Chara helps to stabilize the sediment on the bottom of the lake as well as provides food and habitat for many aquatic animals.

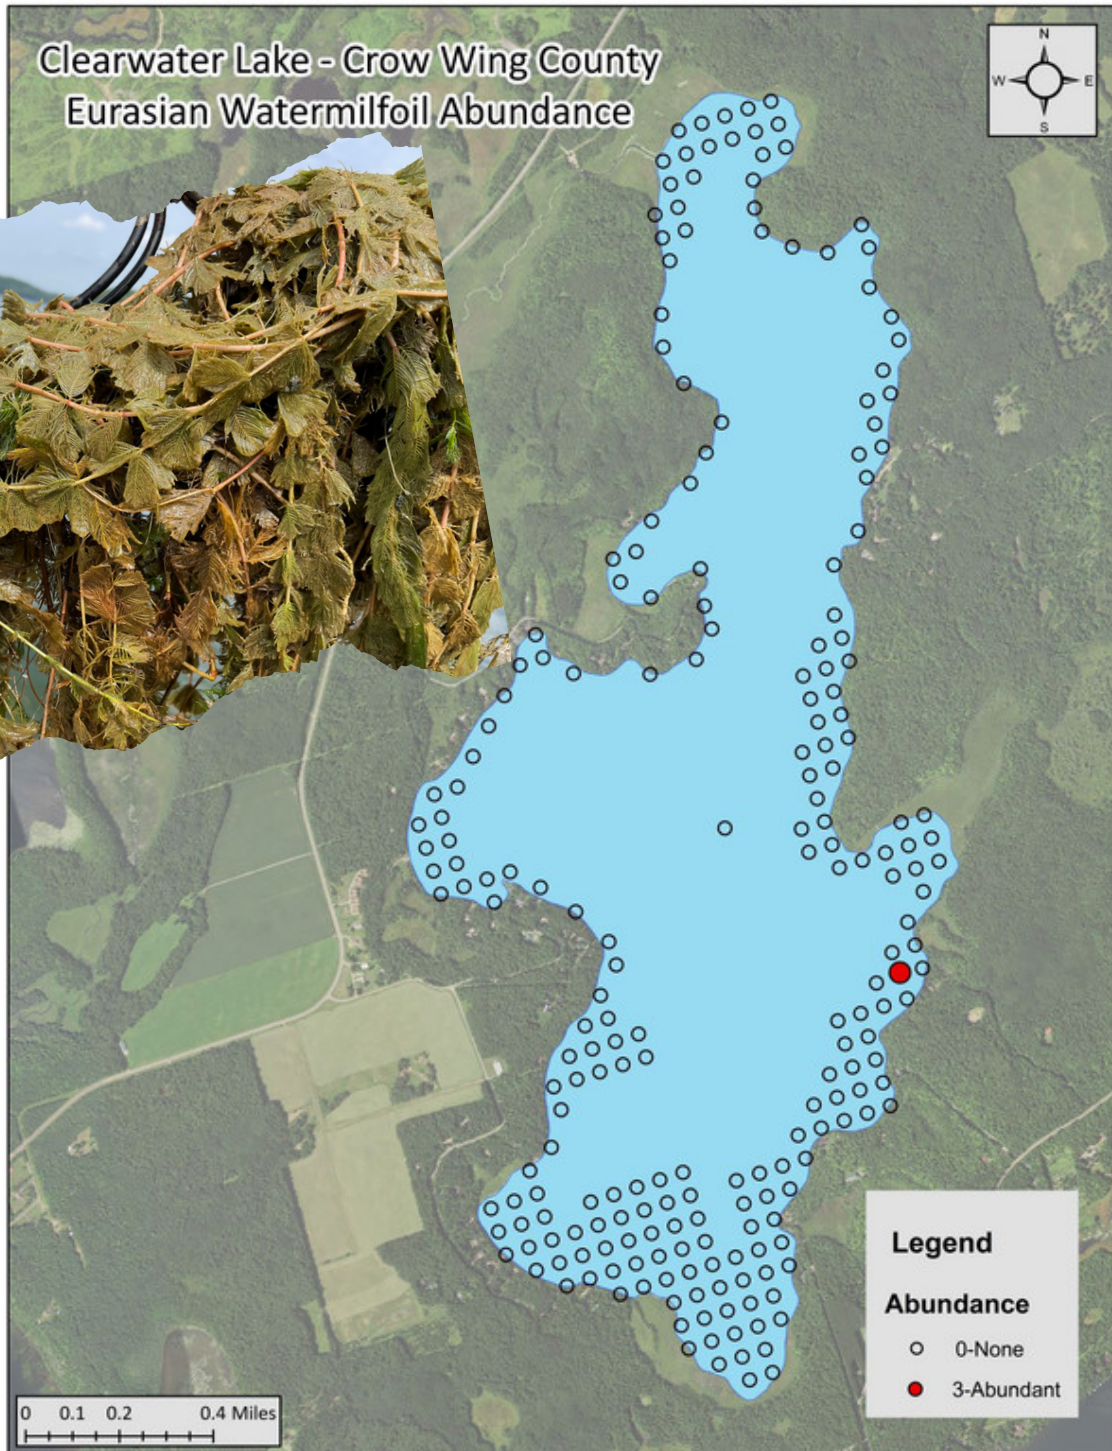
Clearwater Lake - Crow Wing County
Eurasian Watermilfoil Abundance

Eurasian watermilfoil reaches peak growth in mid-summer and can flower twice a year. It forms thick mats that reduces the amount of sunlight that the native plants can receive. Eurasian watermilfoil was only found at one location in 2021; however it was very dense in this area.

Eurasian watermilfoil was the only invasive species found on Clearwater Lake. It was only observed in one location during this survey. This could be due to the fact that treatment had occurred before the survey was completed. In order to better understand the distribution of Eurasian watermilfoil, it would be best to have a survey completed before treatment is performed.

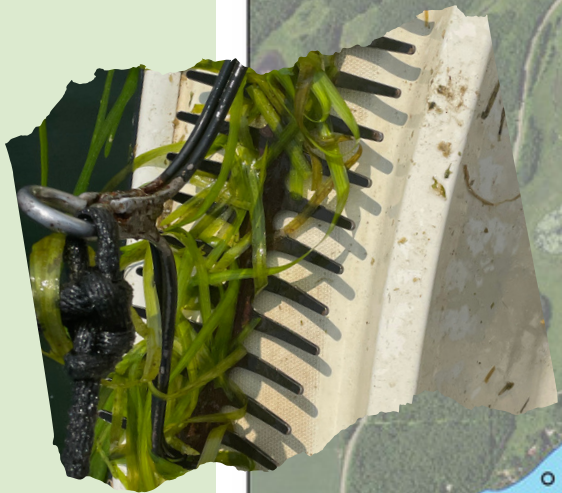
Celery (*Vallisneria americana*)

Water celery prefers sandy sediment in lakes and streams. The leaves can appear wavy and have a wide stripe of cells down the middle that can appear shiny. The female flowers have long spiraled stalks that are often seen in groups around mid-summer.

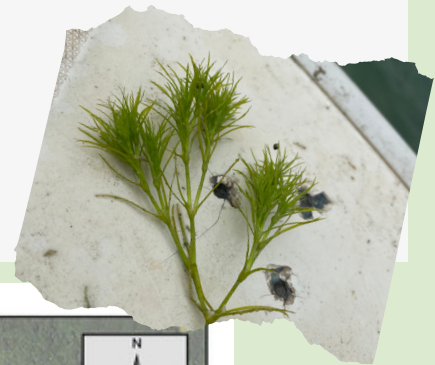
Bushy Pondweed (*Najas flexilis*)

Bushy pondweed is the common name for slender naiad. It can be found in shallow or deep areas of lakes but is most commonly found growing with chara spp. It can grow up to 1 meter long, but is typically found much shorter.
