# 2022 Eurasian Watermilfoil Delineation

**Clearwater Lake** (#18-0038) Crow Wing County, MN

Surveyed August 10, 2022

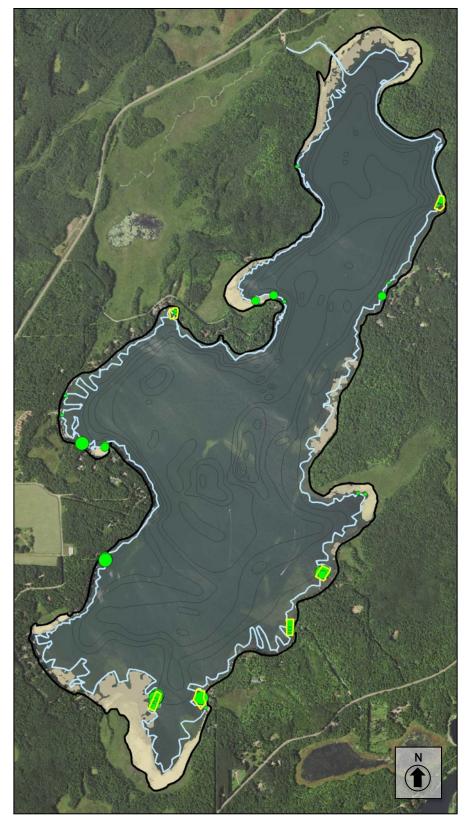
## 2022 Eurasian Watermilfoil Delineation Survey Clearwater Lake (#18-0038)

Freshwater Scientific Services surveyed Clearwater Lake on August 10, 2022. During this survey, we navigated a meandering path over the search area while using a combination of surface observations, sonar readings, and rake tosses to locate and delineate areas of EWM growth. When we encountered EWM plants, we marked the location, recorded the water depth, and rated the density of the growth using visual or rake density scores as described in the table below. The recorded water depths and density scores were linked to the appropriate GPS locations and then mapped using desktop GIS software.

Score	Visual	Rake
1	Light / Solitary plants	1-2 stems
2	Moderate / Scattered dense patches	3 to 9 stems
3	Dense / Uniform dense growth	10+ stems

Surveyed: Aug 10, 2022 Surveyor: JA Johnson Methods: Visual, Sonar, Rake

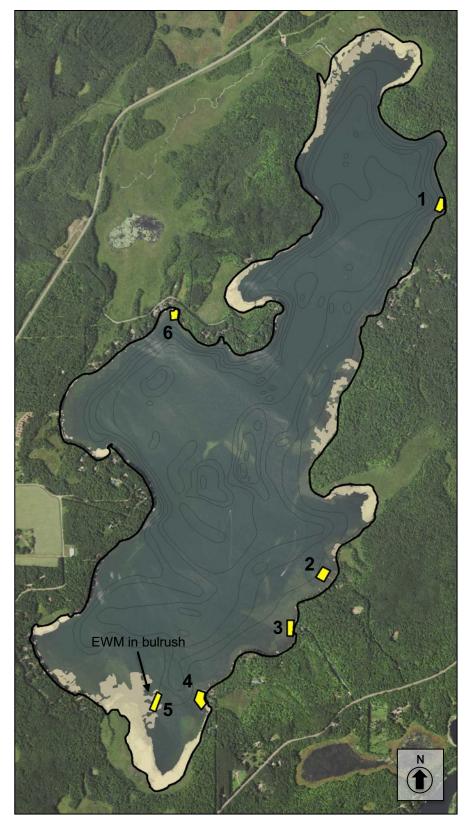
## 2022 Eurasian Watermilfoil Management Plots Clearwater Lake (#18-0038)

Acres	Mean Depth <i>(ft)</i>	Mean EWM Density (1-3)
0.7	4.5	1.7
0.8	4.8	2.5
0.8	3.4	2.0
1.1	3.3	3.0
0.8	4.0	2.3
0.6	3.8	1.0
	0.7 0.8 0.8 1.1 0.8	Acres Depth (ft)   0.7 4.5   0.8 4.8   0.8 3.4   1.1 3.3   0.8 4.0

Total 4.8 acres

(1) Plot #5 is in a stand of bulrush. Discuss management options with your applicator and AIS Specialist to minimize damage to bulrush.

(2) All of these plots are small and may be difficult to treat effectively due to high dilution and drift. Prior to any treatment, discuss options for treating small plots with your applicator.

We found several smaller areas of EWM that were too small to warrant management with herbicides. As an alternative management strategy at these sites, we recommend manual removal by divers (see details on page 5).

Two of the identified plots (#1 and #6) had lighter EWM growth. Although we recommend using herbicide on these areas, manual removal may be a viable alternative.

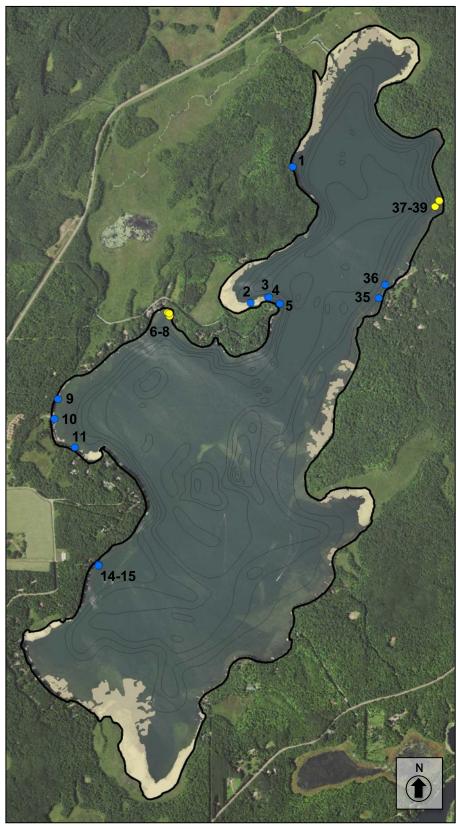
## **2022 Eurasian Watermilfoil Manual Removal (Alternative Management) Clearwater Lake** (#18-0038)

Site	Depth (ft)	Lat*	Long*
1	4.6	46.407278	-93.910394
2	3.3	46.400691	-93.913199
3	4.9	46.400975	-93.912008
4	5.9	46.400973	-93.911938
5	5.9	46.400671	-93.911176
6	3.9	46.400012	-93.918848
7	4.3	46.400190	-93.919000
8	3.3	46.400148	-93.918873
9	2.6	46.395937	-93.926547
10	3.0	46.394989	-93.926789
11	2.0	46.393638	-93.925345
14	4.6	46.387995	-93.923584
15	4.3	46.387953	-93.923585
35	5.2	46.400991	-93.904267
36	4.9	46.401635	-93.903838
37	4.9	46.405429	-93.900425
38	3.9	46.405685	-93.900123
39	4.6	46.405735	-93.900170

The points marked with yellow are in identified treatment plots. EWM in these areas was light, but there were substantially more plants than marked with points. If the lake group decides to treat these areas with herbicide (recommended), the yellow points will not require hand-pulling.
