## 2021 Eurasian Watermilfoil Delineation

**Clearwater Lake** (#18-0038)  
Crow Wing County, MN

Surveyed September 13, 2021

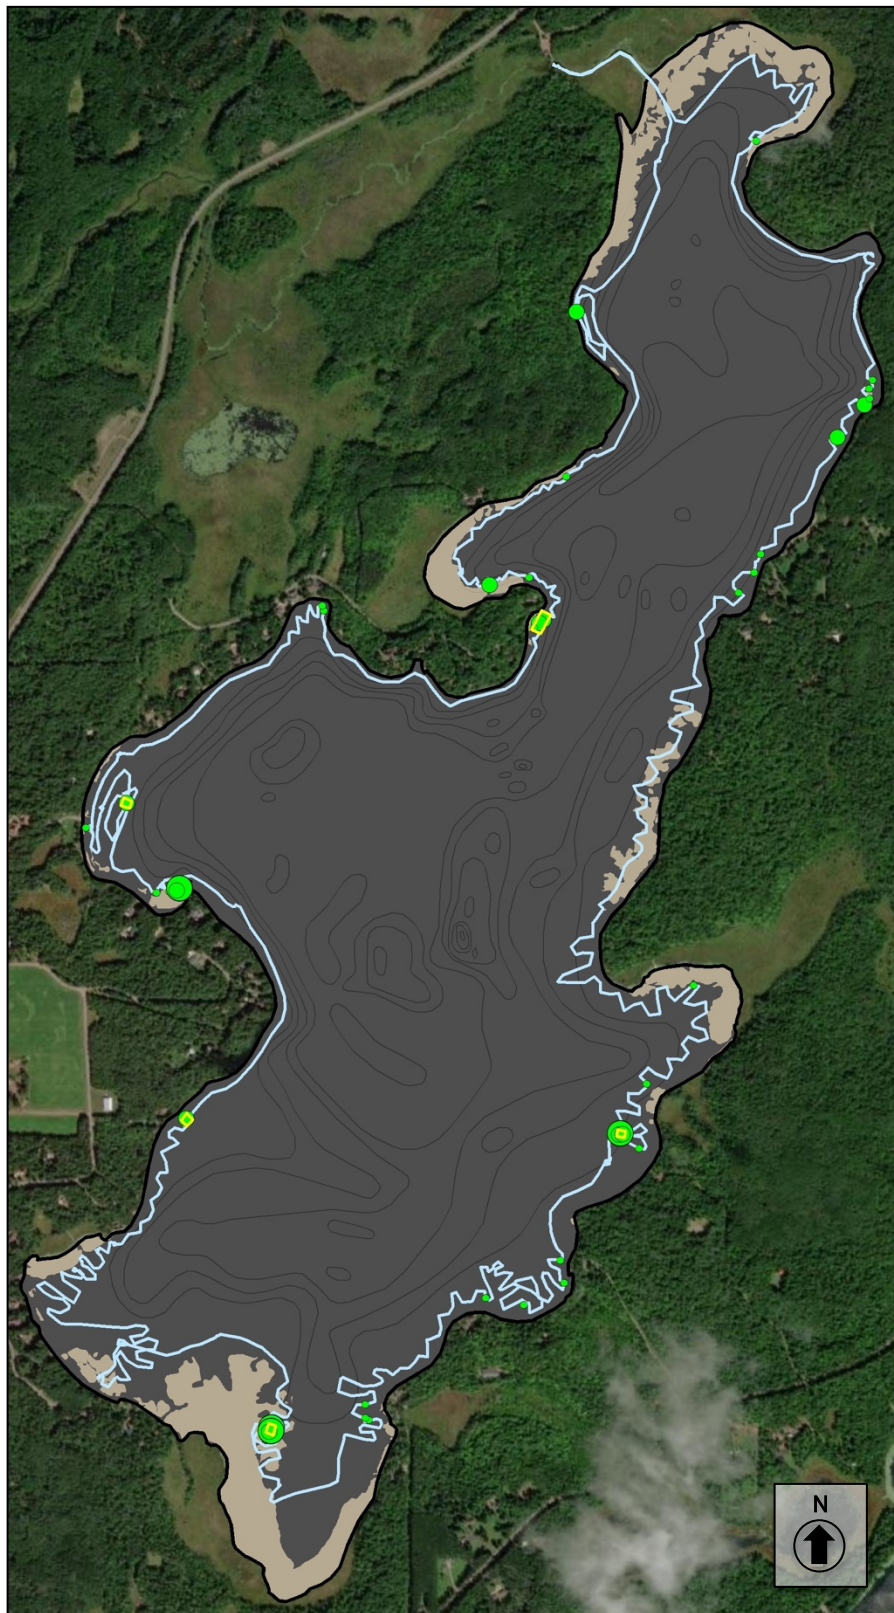
## 2021 Eurasian Watermilfoil Delineation Survey

**Surveyed:** Sept 13, 2021  
**Surveyor:** JA Johnson  
**Methods:** Visual, Sonar, Rake

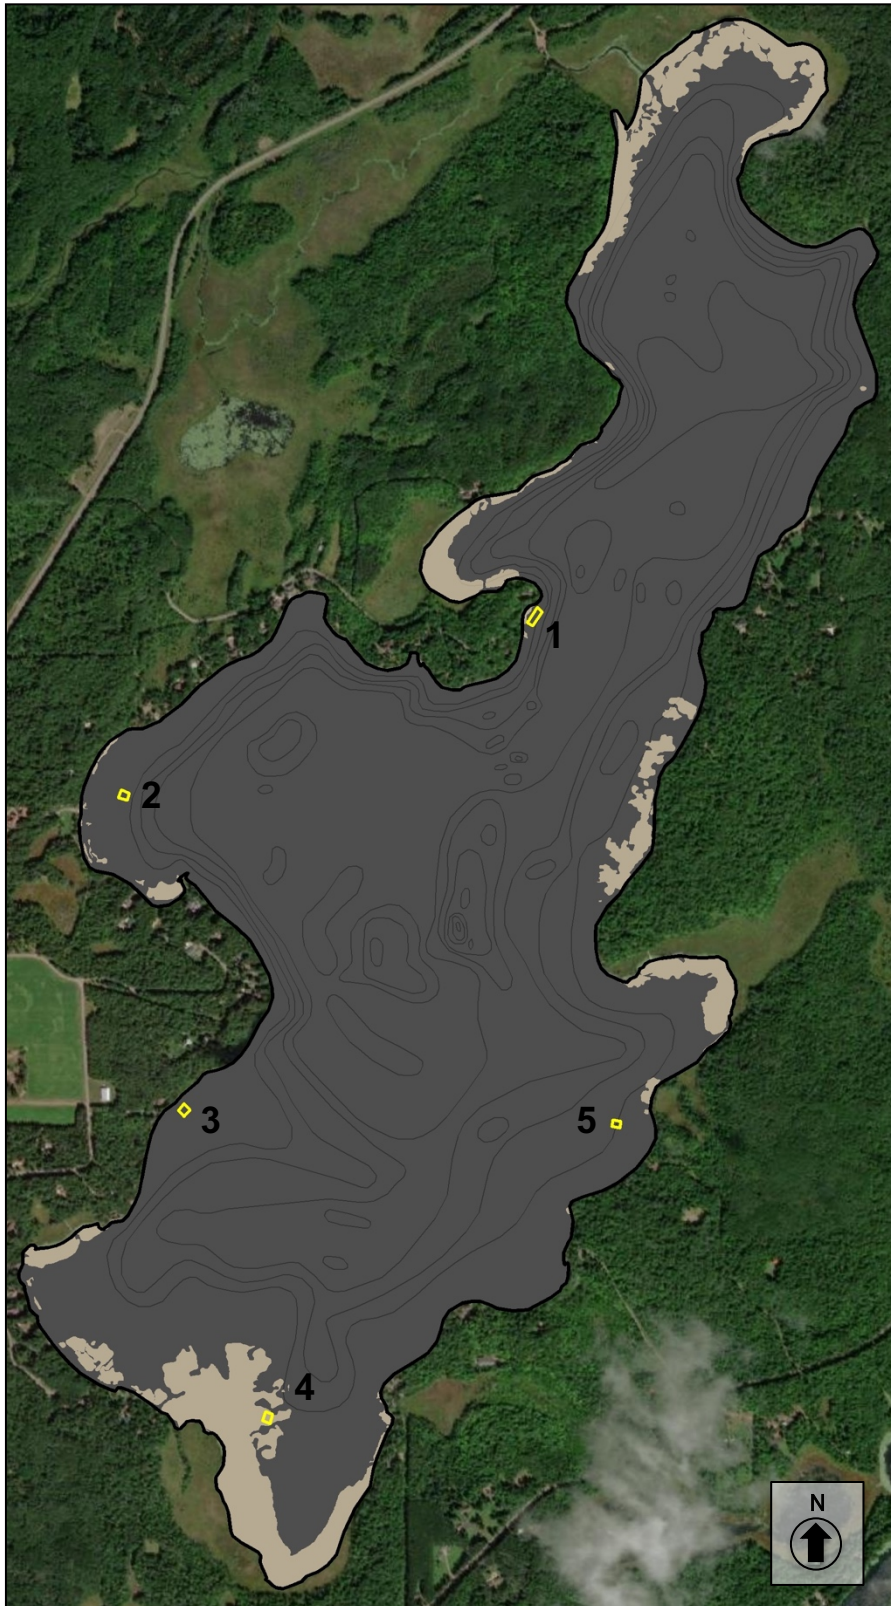
## 2021 Eurasian Watermilfoil Management Plots

Plot	Acres	Mean Depth (ft)	Mean EWM Density (1-3)
1	0.19	4.2	1.7
2	0.12	5.9	2.0
3	0.13	4.0	2.0
4	0.13	3.0	2.7
5	0.10	5.0	2.3

Plots 1, 2, and 3 have only a few very small patches (2-3 feet across); plots 4 and 5 have larger and denser patches of EWM (20-30 feet across). There is an additional dense patch of EWM south of plot 2 where the property owner has requested no herbicide treatment.

All of these plots are very small and will be difficult to treat effectively due to high dilution and drift of any applied herbicide. If you decide to pursue herbicide treatment of any plots, discuss options for treating small plots with your hired applicator.

Manual removal of EWM by divers would be a feasible and effective management strategy for the identified areas of EWM. Hand-pulling would also allow for removal of solitary plants located outside of identified plots and surgical removal of EWM in areas adjacent to lilies, bulrush, and other desirable plants. The DNR would still require a permit for manual removal – contact your AIS specialist for additional details.

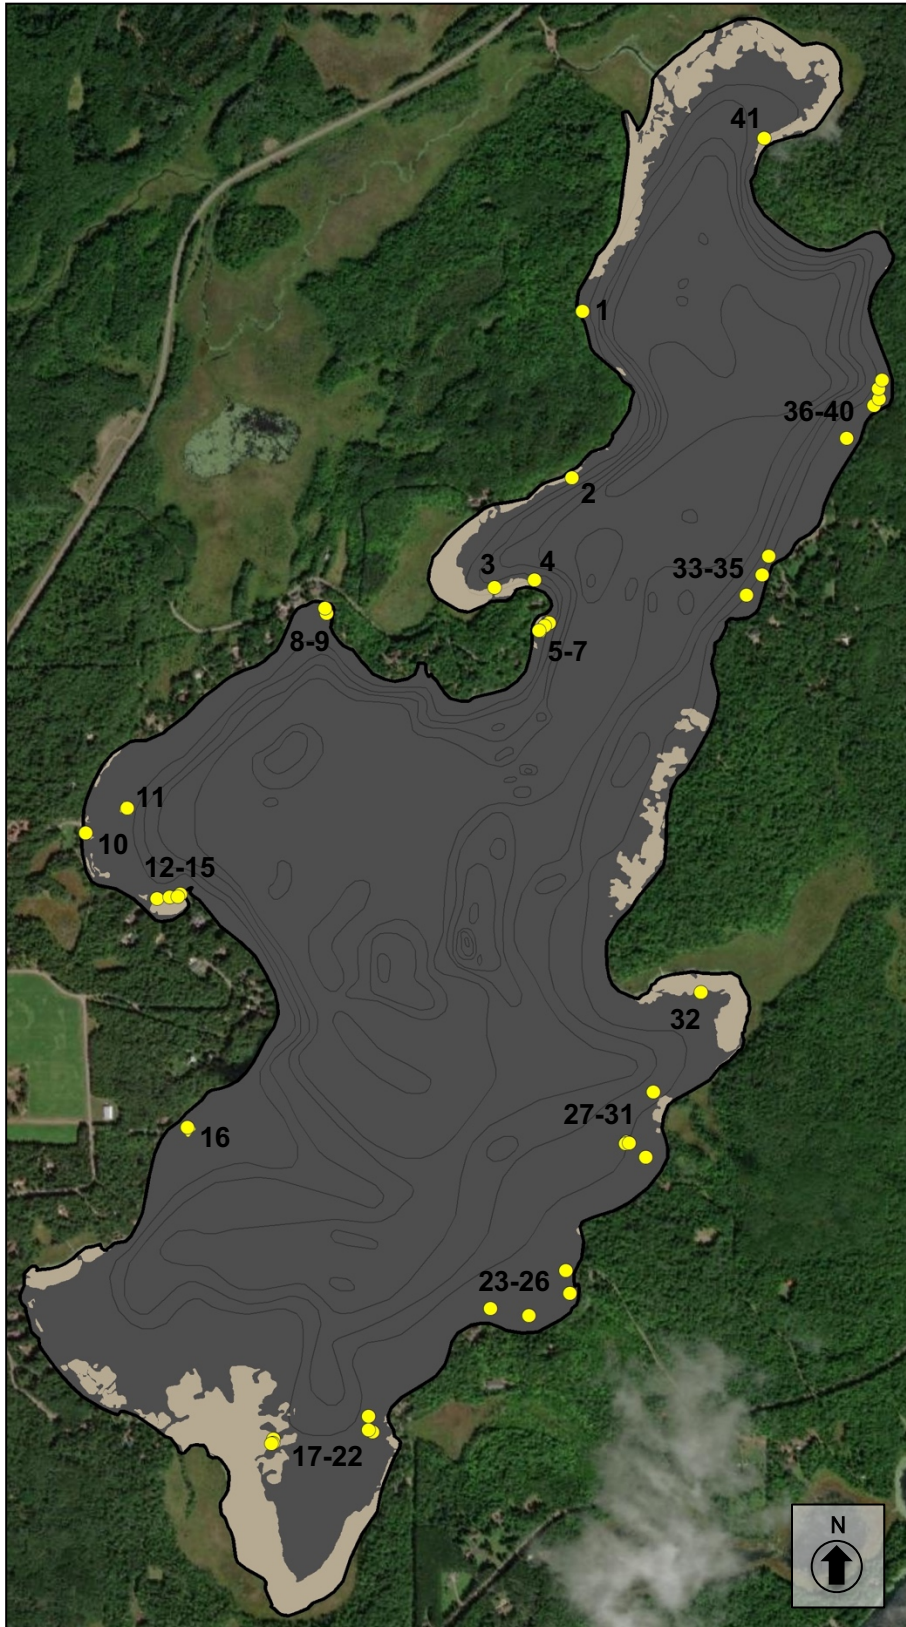
## 2021 Eurasian Watermilfoil Manual Removal (Alternative Management) Clearwater Lake (#18-0038)

Site	Depth (ft)	Lat	Long
1	6.6	46.407238	-93.910343
2	4.9	46.403342	-93.910645
3	3.9	46.400765	-93.913200
4	4.9	46.400955	-93.911862
5	4.9	46.399954	-93.911350
6	4.9	46.399875	-93.911500
7	2.6	46.399767	-93.911694
8	3.0	46.400112	-93.918862
9	2.6	46.400229	-93.918918
10	1.0	46.394925	-93.926898
11	5.9	46.395516	-93.925514
12	2.0	46.393406	-93.924468
13	5.9	46.393448	-93.924041
14	4.9	46.393520	-93.923693
15	4.9	46.393466	-93.923764
16	3.9	46.388074	-93.923351
17	3.3	46.380823	-93.920327
18	3.0	46.380729	-93.920343
19	2.6	46.380716	-93.920391
20	5.2	46.381016	-93.916999
21	5.2	46.381063	-93.917133
22	4.9	46.381382	-93.917128
23	3.9	46.383937	-93.913060
24	2.3	46.383778	-93.911756
25	3.0	46.384309	-93.910387
26	2.3	46.384845	-93.910540
27	2.6	46.387509	-93.907881
28	5.2	46.387860	-93.908543
29	5.2	46.387820	-93.908566
30	4.6	46.387836	-93.908448
31	4.3	46.389030	-93.907645
32	3.0	46.391374	-93.906087
33	3.9	46.400652	-93.904711

34	4.6	46.401128	-93.904190
35	4.9	46.401568	-93.903974
36	3.3	46.404345	-93.901385
37	2.3	46.405115	-93.900476
38	2.6	46.405267	-93.900313
39	4.3	46.405501	-93.900336
40	4.3	46.405709	-93.900205
41	4.3	46.411319	-93.904283

Higher priority sites highlighted
