## Clearwater Lake Community Runoff Mini-Grant, 2018

#### Clearwater Community Runoff Mini-Grant Summary

# Clearwater Lake Community Runoff Mini-Grant, 2018

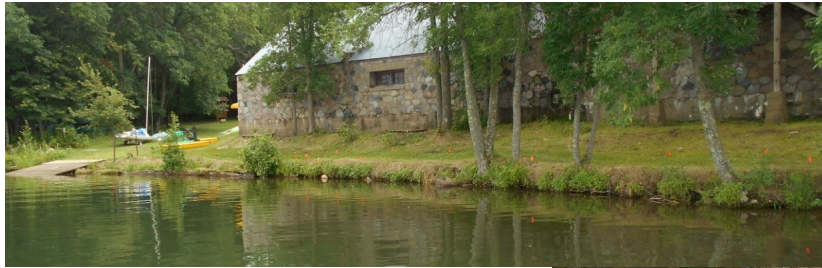
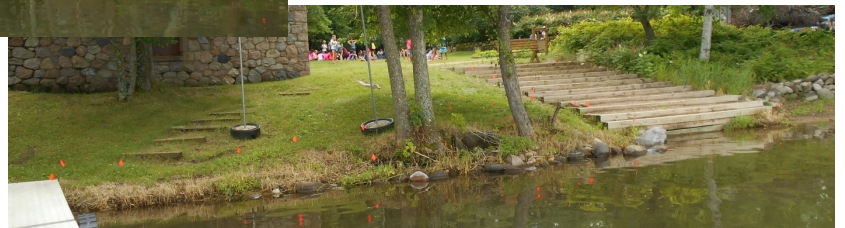
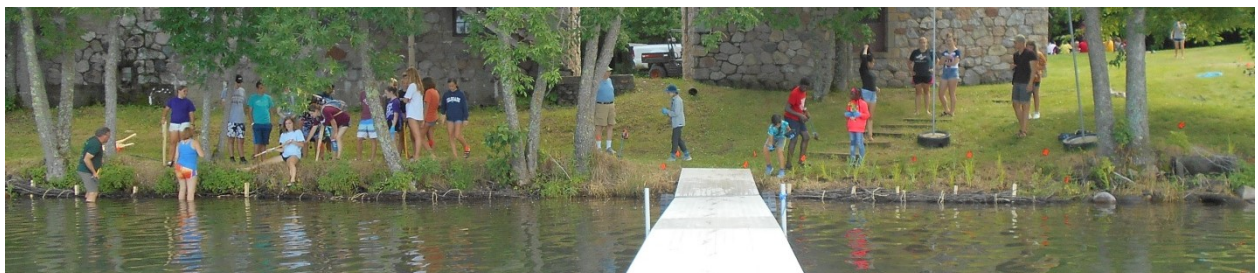
### Worship Area and Water Recreation Areas

- Worship Area
  - Install 30' x 2' of willow wattle, Install 15' x 20' upland bank planting
- Swim/Boat/Kayak Launch Area
  - Install 120' x 2' of willow wattle, Install 10' x 15' upland bank planting, Plant shrubs along 500 feet of shore
- Chickadee Day Camp
  - Install 60' x 2' of willow wattle

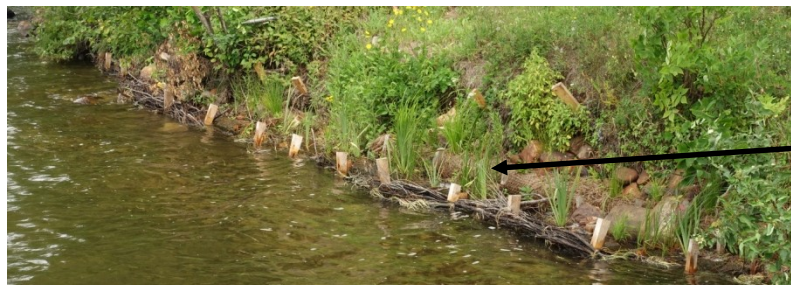
### Damaged Banks Repaired

- Damaged Banks Repaired
  - Install 2, 1' x 30' C700 steps
  - Install 1, 1' x 20' C700 steps
  - Repair damaged bank 8' x 15' with Curlex Erosion Blanket. A large amount of concrete and trash was removed from the shoreline prior to installation.
- Willow Wattle Install
  - 150' x 2' of willow wattle
- Upland Buffers
  - Plant 3 Upland Buffers 10' x 50', 9' x 30', and 10' x 28'
  - One upland Buffer 500 square feet *on hold* until retaining wall can be repaired. This part of the project will not be paid with grant funds.
- Rain Garden
  - Repair and Replant an existing rain garden 8' x 15'

**Bio Engineered Steps**

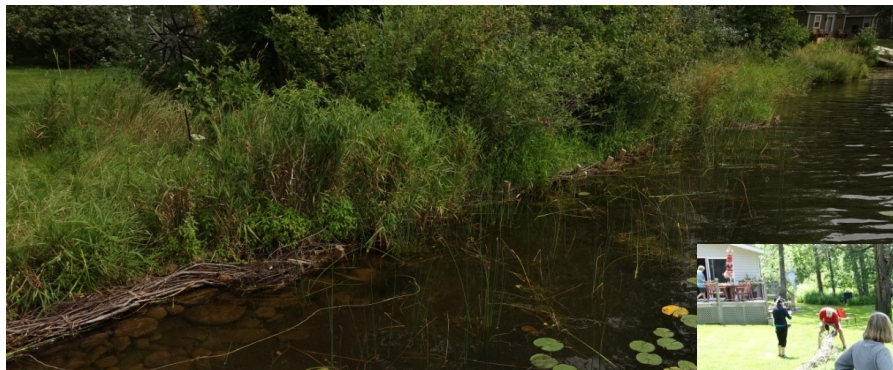
### Willow Wattle Install

- Willow Wattle Install
  - 120 feet willow wattle installed
  - An additional 20 feet were installed post project with extra supplies.
- Runoff Area
  - A low area next to the dock

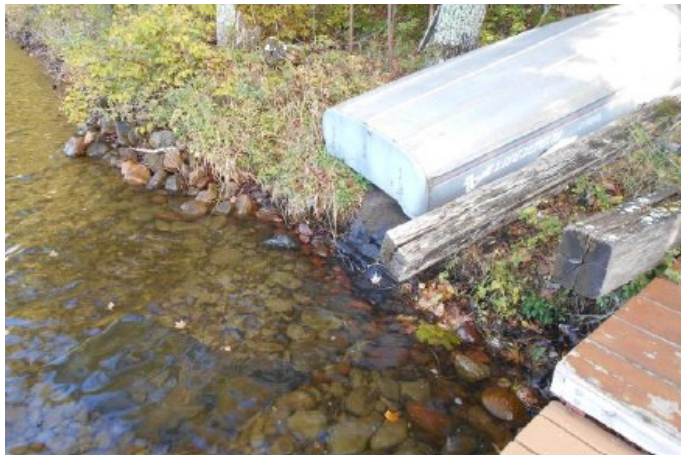
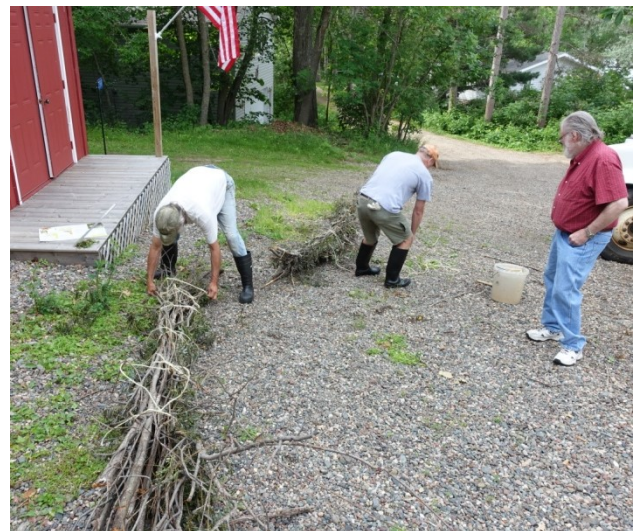
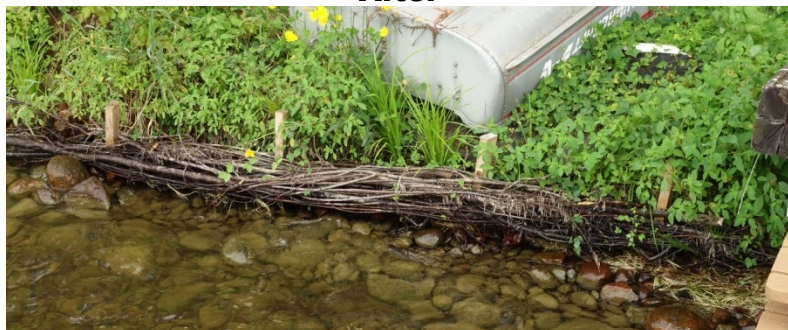
### Willow Wattle Install

- Willow Wattle Install
  - 12' x 2' of willow wattle installed
- Runoff Area
  - 36' x 3' of bank planted to capture and filter runoff, stabilize the bank
  - 20' x 6' of upland area planted in runoff area

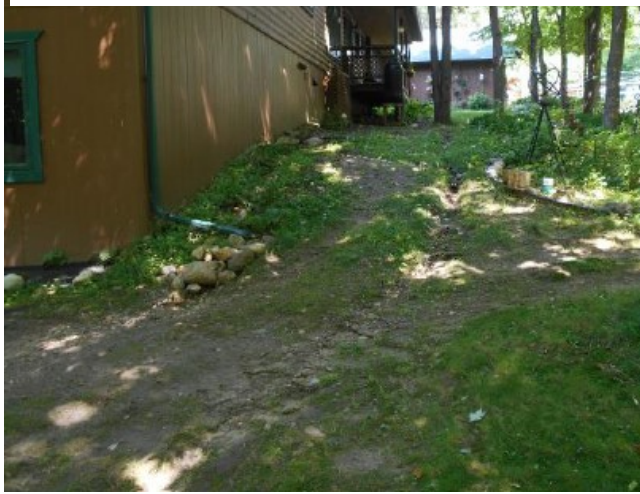
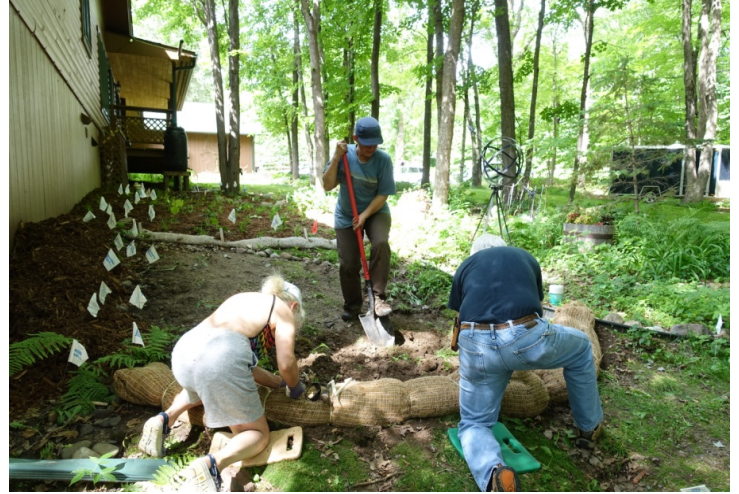
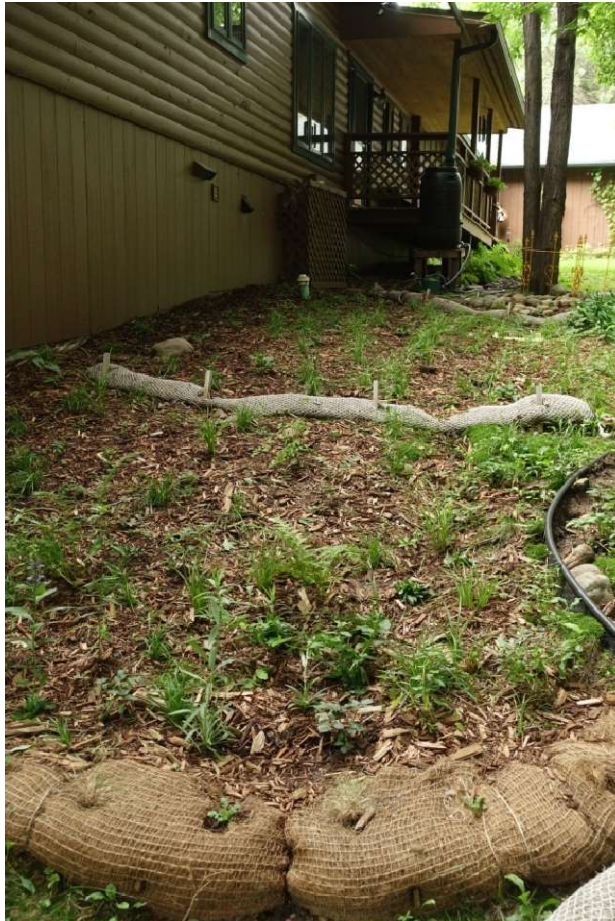
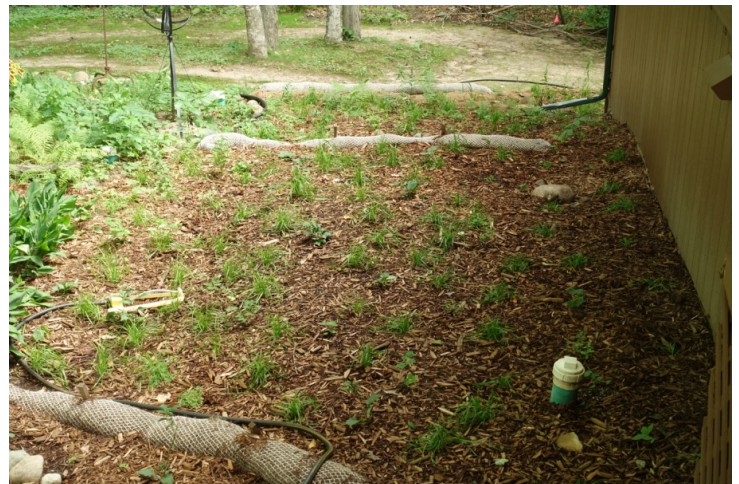
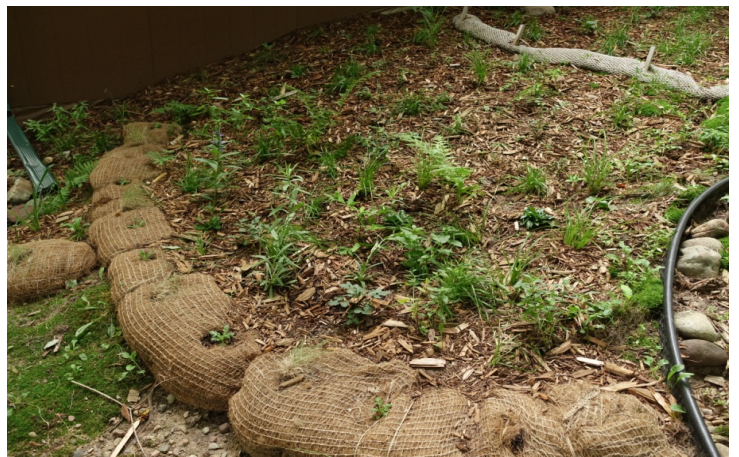
## Rain Garden 1 with Large Eroded Slope

- Rain Gardens
  - 3 Rain Gardens install on south and south east side of house.
  - 3 slope checks were installed
  - Large upland area that had major erosion damage was planted

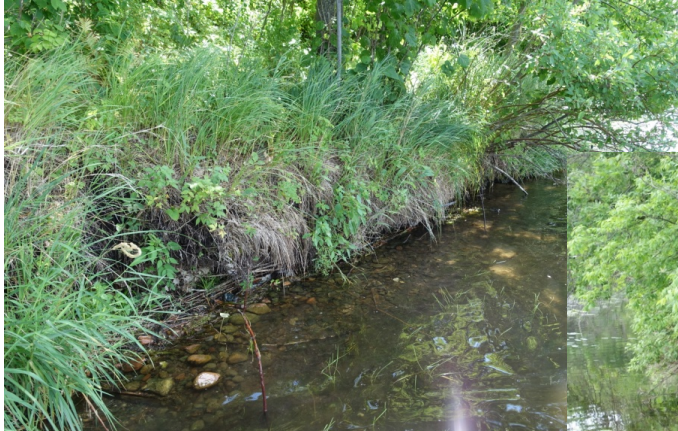
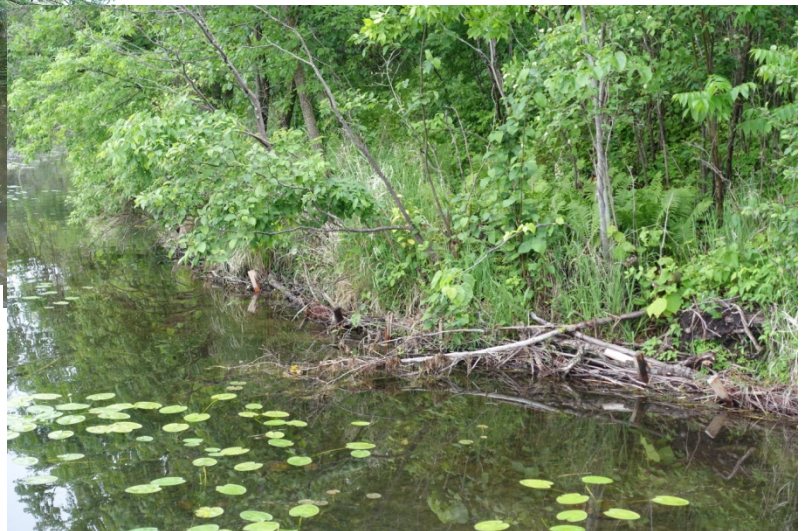
## Willow Wattle Install

- Willow Wattle Install
  - 56 feet of willow wattle installed in 2018
  - 100 feet installed prior to project kickoff and not paid for with Grant Funds. This was done to understand the type of project and help decide if a grant should be applied for.

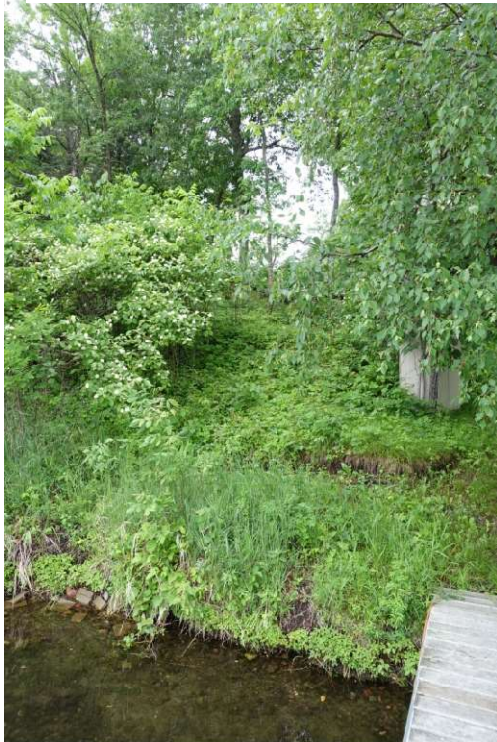
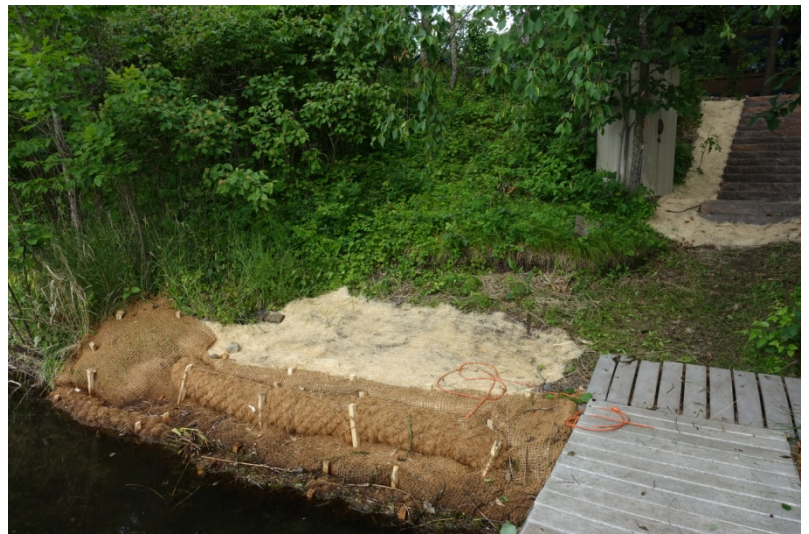
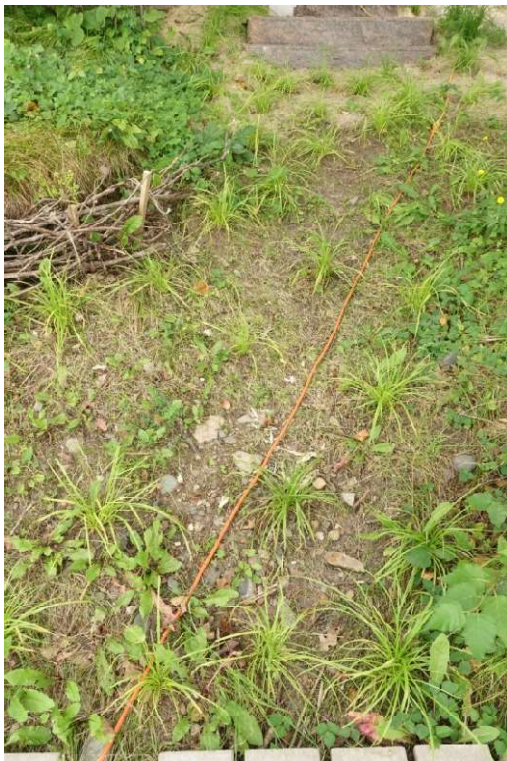
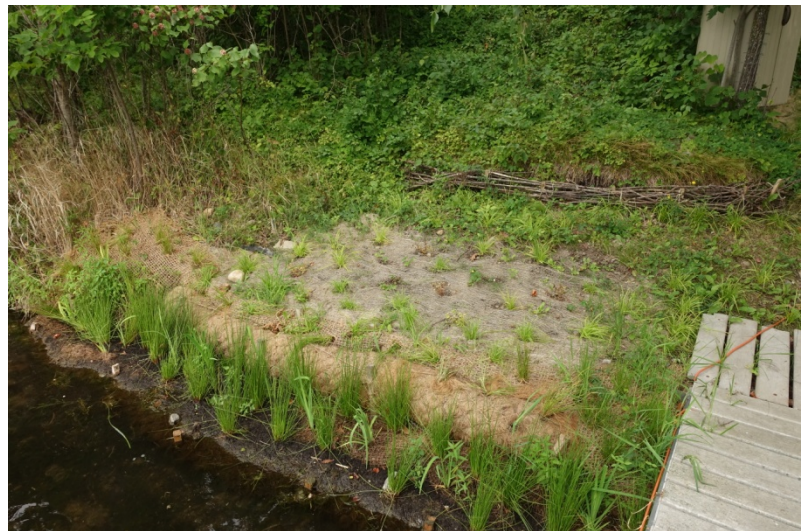
## Restructured Damaged Kayak Access

- Restructured Damaged Kayak Access
  - Damaged ice ridge restructured with 3 steps 12' x 1' feet of stabilization with Coir Logs for access to lake for kayak launching

- 12' x 5' foot section restructured with Curlex erosion blanket
- Vegetated Swale behind a Historic Ice Ridge
  - An area behind a historic ice ridge that drains into a fresh spring break in the ridge was planted to slow runoff

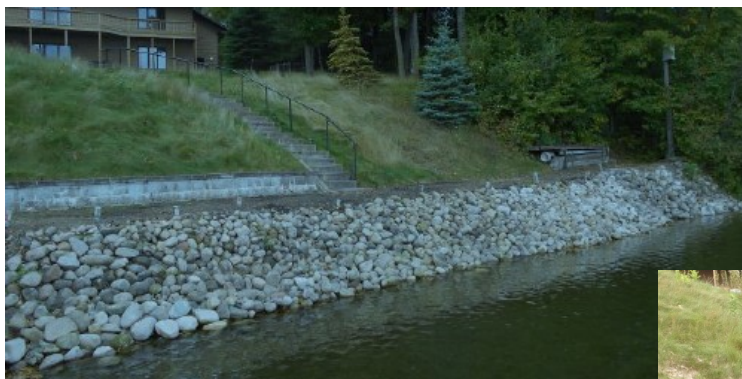
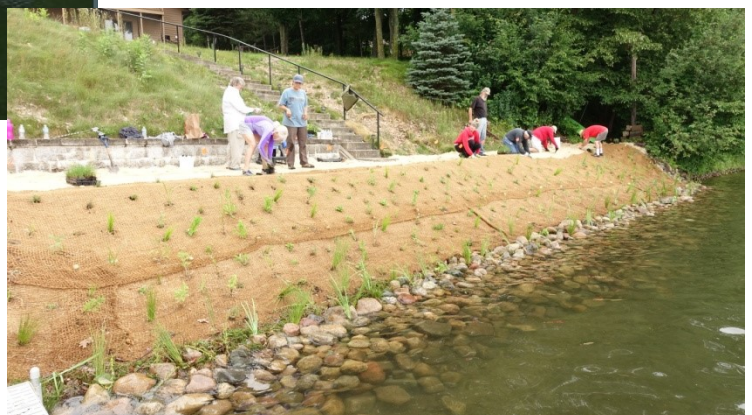
### Rip Rap Area

- Rip Rap Area
  - 150 feet by 12 feet bank re-stabilized using Curlex and Cocomat 700 blankets
- North and South Upland Areas
  - 560 square feet of upland terraces were planted behind the restabilized rip rap area.
- Upland Slope planting
  - 1200 square feet was postponed to next summer. This part of the project will not be paid with grant funds.

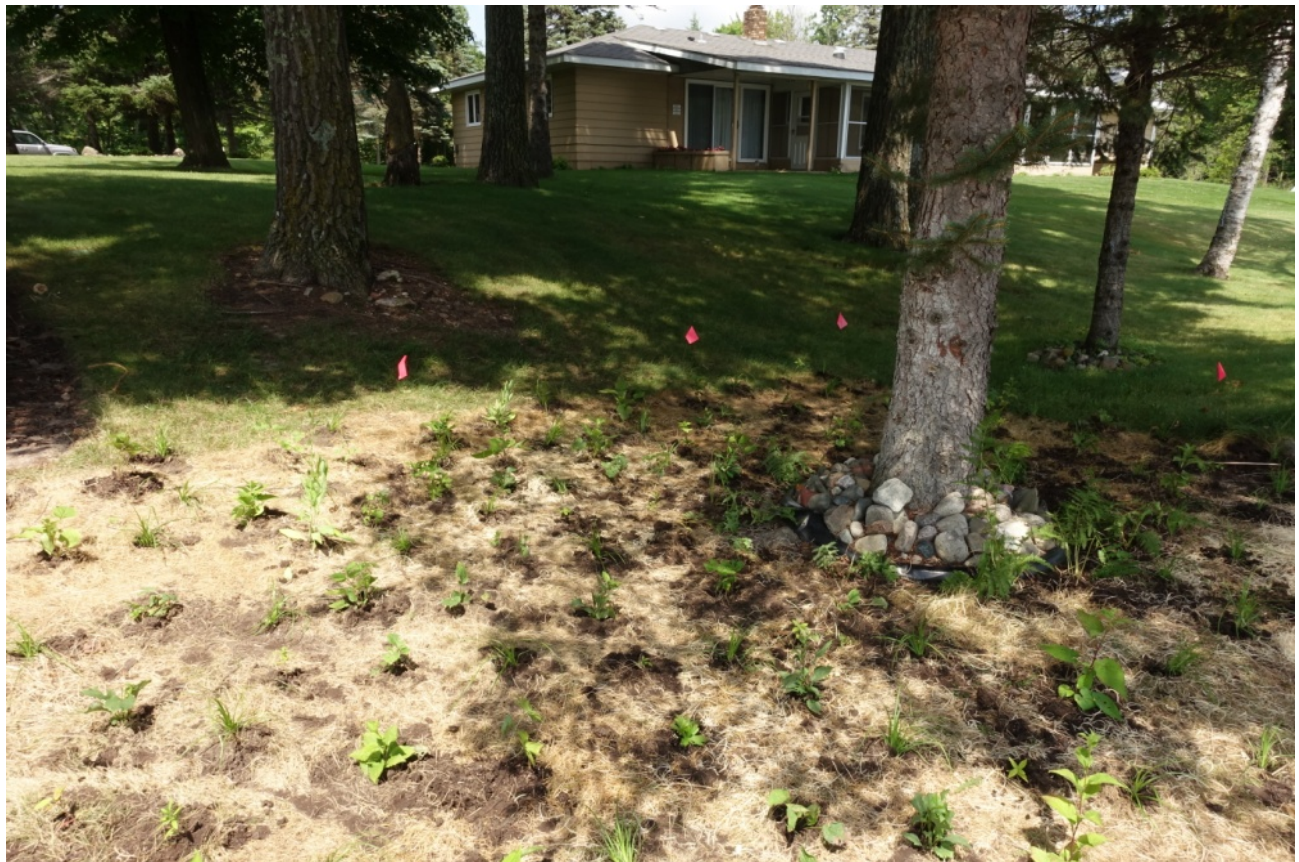
### Upland Shady Buffer

- Upland Shady Buffer
  - Created a 15' x 14' upland shady buffer above shoreline
- Damaged Rip Rap Area
  - 50' x 6' of ice damaged riprap pulled lake ward and re-stabilized
  - 64' x 6' of ice damaged riprap pulled lake ward and re-stabilized

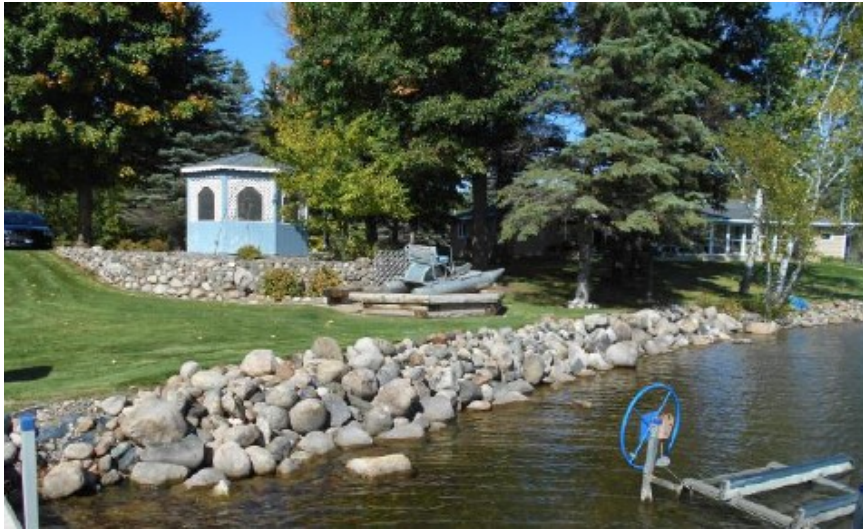
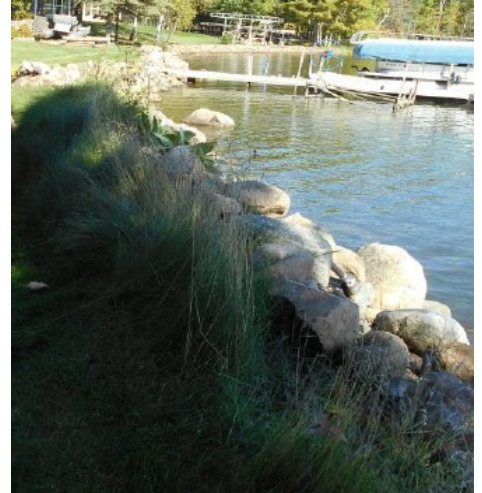
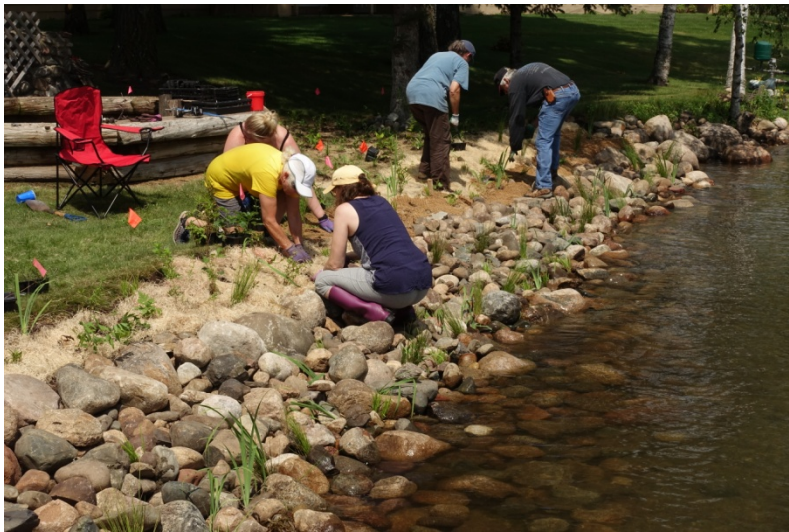
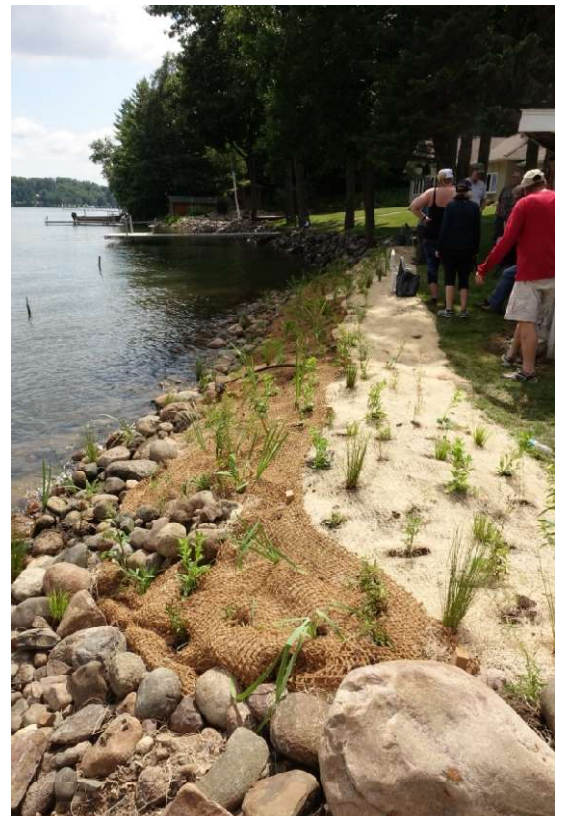
## Ice Damaged Riprap Area

**Ice Push**
